JH-7110 Errata Sheet

Doc ID: JH-7110-ESEN-001

This document mainly provides information about known device issues affecting StarFive SoC JH-7110.

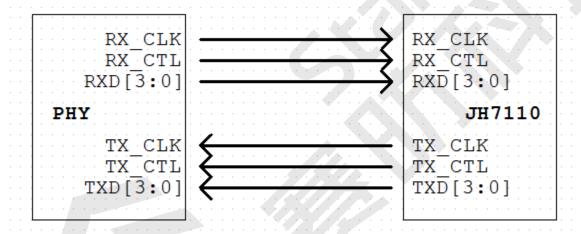
Figure 1-1 GMAC 1,000 M Only

JH-7110 only supports RGMII mode for Ethernet GMAC connections.

If you only need to support 1,000 M mode, you can design the layout following the requirements below.

- The RX/TX trace length cannot exceed 6,000 mil.
- Match the RXD[3:0] signal group and the RX_CTL and RX_CLK signals with trace length to within 100 mil. Match the TXD[3:0] signal group and the TX_CTL and TX_CLK group trace length to within 100 mil.
- The routing of data and clock lanes should keep a complete reference plane.

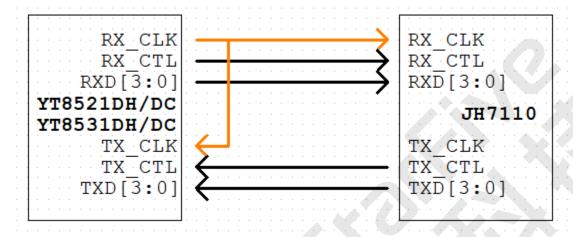
Figure 1-2 GMAC 10 M/100 M/1,000 M Auto-Negotiation

For auto-negotiation mode, only the following PHY models are supported.

- YT8521DH/DC
- YT8531DH/DC

Plus, you need to connect the RX_CLK of the PHY to its TX_CLK as shown by the orange lines in the following diagram.

- The trace length from TX_CLK to RX_CLK cannot exceed 500 mil.
- The RX and TX trace length cannot exceed 4,300 mil.
- Match the RXD[3:0] signal group and the RX_CTL and RX_CLK signals with trace length to within 100 mil.
- Match the TXD[3:0] signal group and the TX_CTL and RX_CLK signals with trace length to within 100 mil.
- The routing of data and clock lanes should keep a complete reference plane.

- The trace length from TX_CLK to RX_CLK cannot exceed 500 mil.
- The RX_CLK trace length cannot exceed 4,000 mil. Match the RXD[3:0] signal group and the RX_CTL and RX_CLK signals with trace length to within 100 mil.
- The TX_CLK trace length is 2,000 mil longer than that of the RX_CLK. Match the TXD[3:0] signal group and the TX_CTL and RX_CLK signals with trace length to within 100 mil.
- The routing of data and clock lanes should keep a complete reference plane.
