VisionFive 2 Errata Sheet

Version: 1.0

Doc ID: VisionFive2-ESEN-001

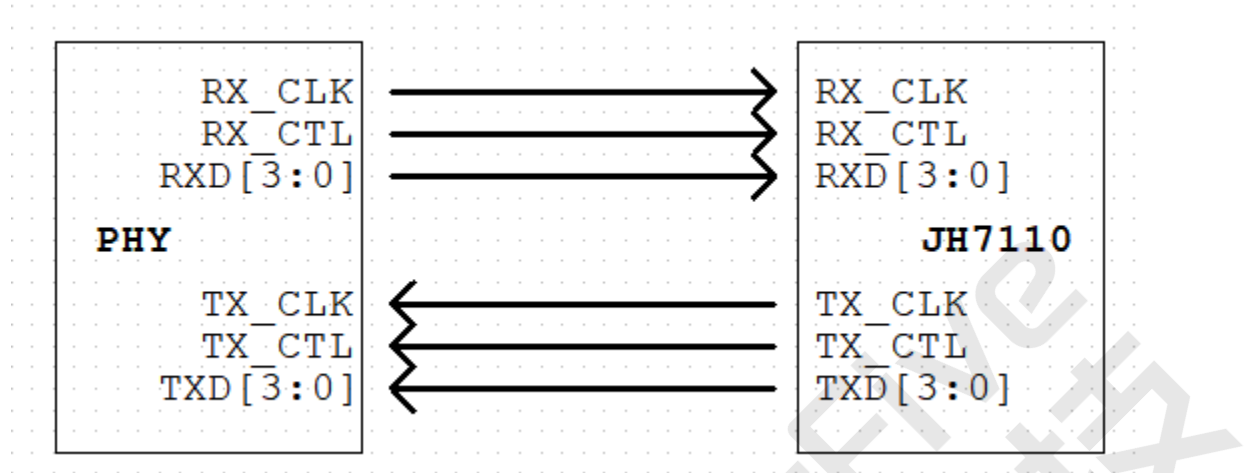
Figure 1-1 GMAC 1,000 M Only

JH-7110 only supports RGMII mode for Ethernet GMAC connections.

If you only need to support 1,000 M mode, you can design the layout following the requirements below.

Layout requirements.

- The RX/TX trace length cannot exceed 6,000 mil.
- Match the RXD[3:0] signal group and the RX_CTL and RX_CLK signals with trace length to within 100 mil. Match the TXD[3:0] signal group and the TX_CTL and TX_CLK group trace length to within 100 mil.
- The routing of data and clock lanes should keep a complete reference plane.

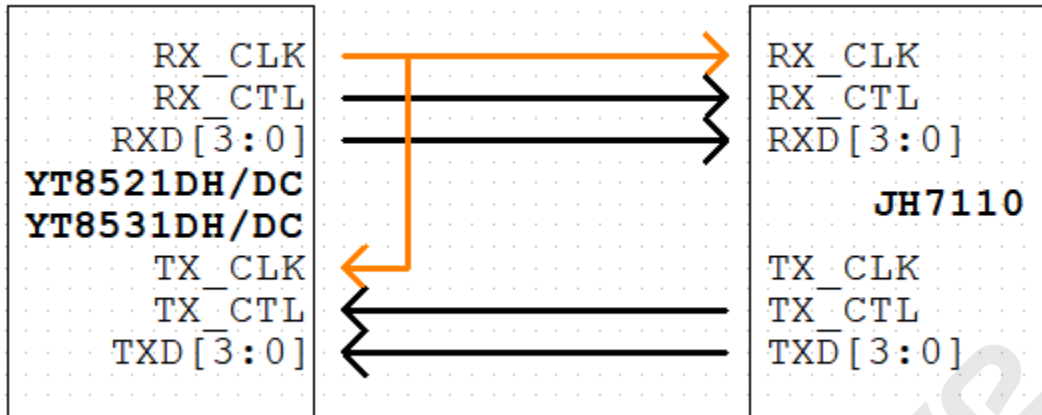
Figure 1-2 GMAC 10 M/100 M/1,000 M Auto-Negotiation

For auto-negotiation mode, only the following PHY models are supported.

- YT8521DH/DC
- YT8531DH/DC

Plus, you need to connect the RX_CLK of the PHY to its TX_CLK as shown by the orange lines in the following diagram.

Layout requirements for GMAC0.

- The trace length from TX_CLK to RX_CLK cannot exceed 500 mil.
- The RX and TX trace length cannot exceed 4,300 mil.
- Match the RXD[3:0] signal group and the RX_CTL and RX_CLK signals with trace length to within 100 mil.
- Match the TXD[3:0] signal group and the TX_CTL and RX_CLK signals with trace length to within 100 mil.
- The routing of data and clock lanes should keep a complete reference plane.

Layout requirements for GMAC1.

- The trace length from TX_CLK to RX_CLK cannot exceed 500 mil.
- The RX_CLK trace length cannot exceed 4,000 mil. Match the RXD[3:0] signal group and the RX_CTL and RX_CLK signals with trace length to within 100 mil.
- The TX_CLK trace length is 2,000 mil longer than that of the RX_CLK. Match the TXD[3:0] signal group and the TX_CTL and RX_CLK signals with trace length to within 100 mil.
- The routing of data and clock lanes should keep a complete reference plane.
